Detailed Project Report
Mitigation of Mangan Landslide at North District Headquarters
Mangan, North Sikkim - India

Submitted by
Sikkim State Disaster Management Authority (SSDMA)
Land Revenue & Disaster Management Department (LR&DMD)
Government of Sikkim – July, 2018

COMPLIANCE REPORT

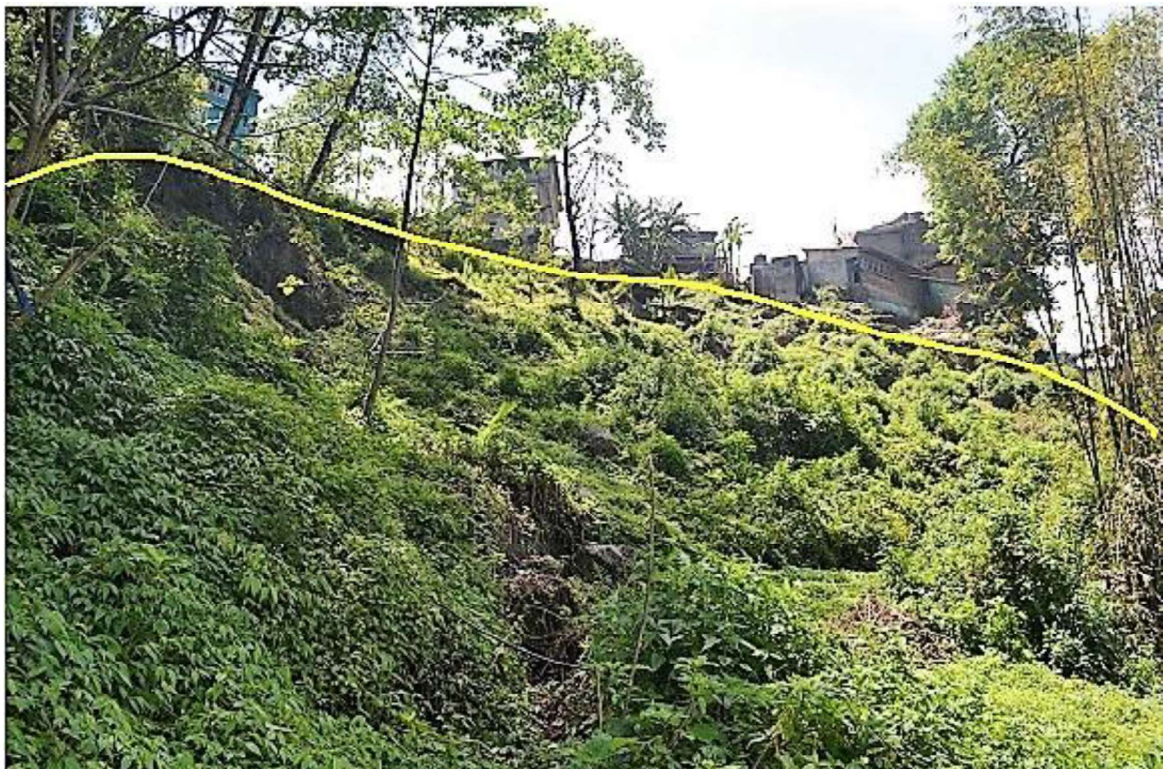
Fig 7: Showing crown portion of the slide zone below SNT complex.

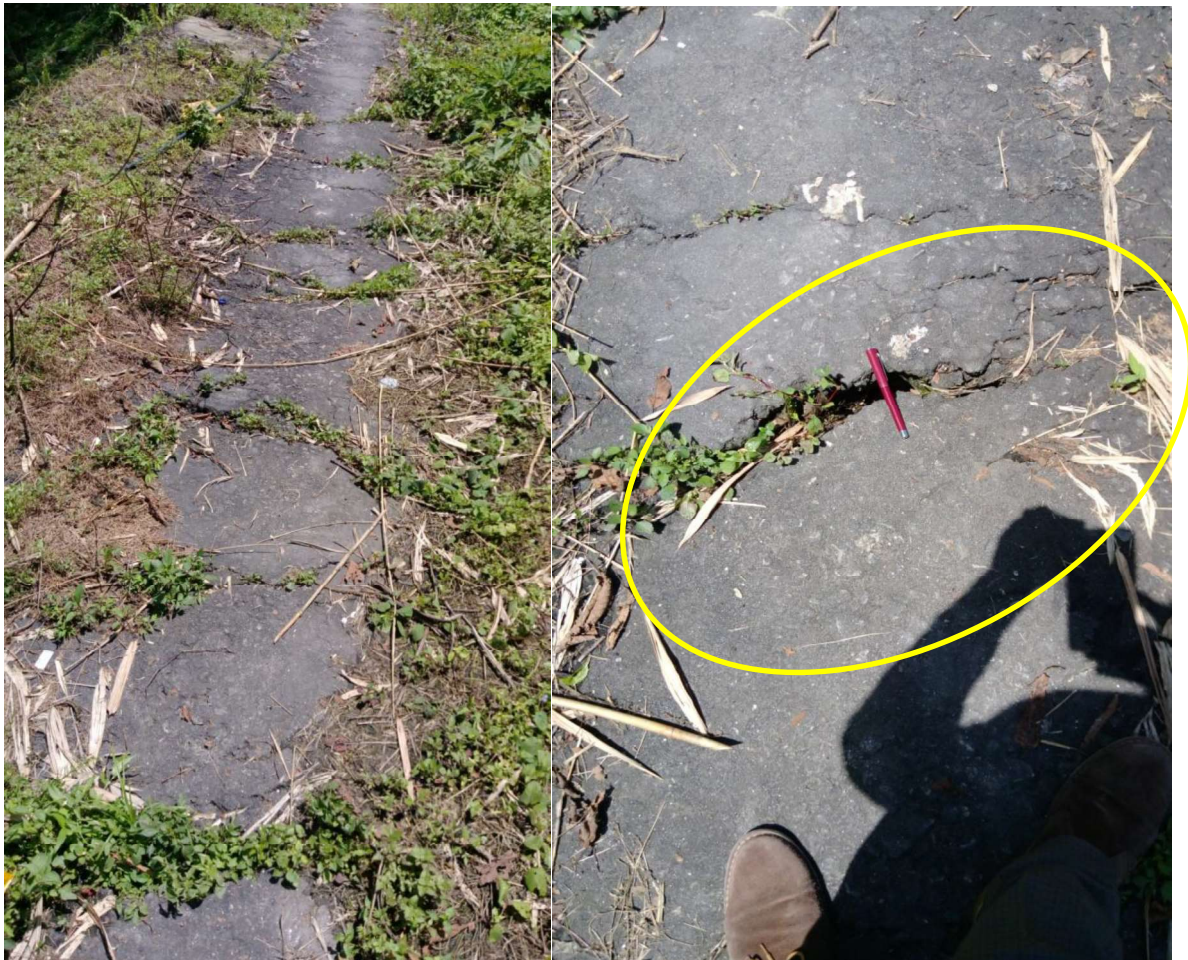
Fig 9: Showing cracks in the road in the slide zone below SNT complex

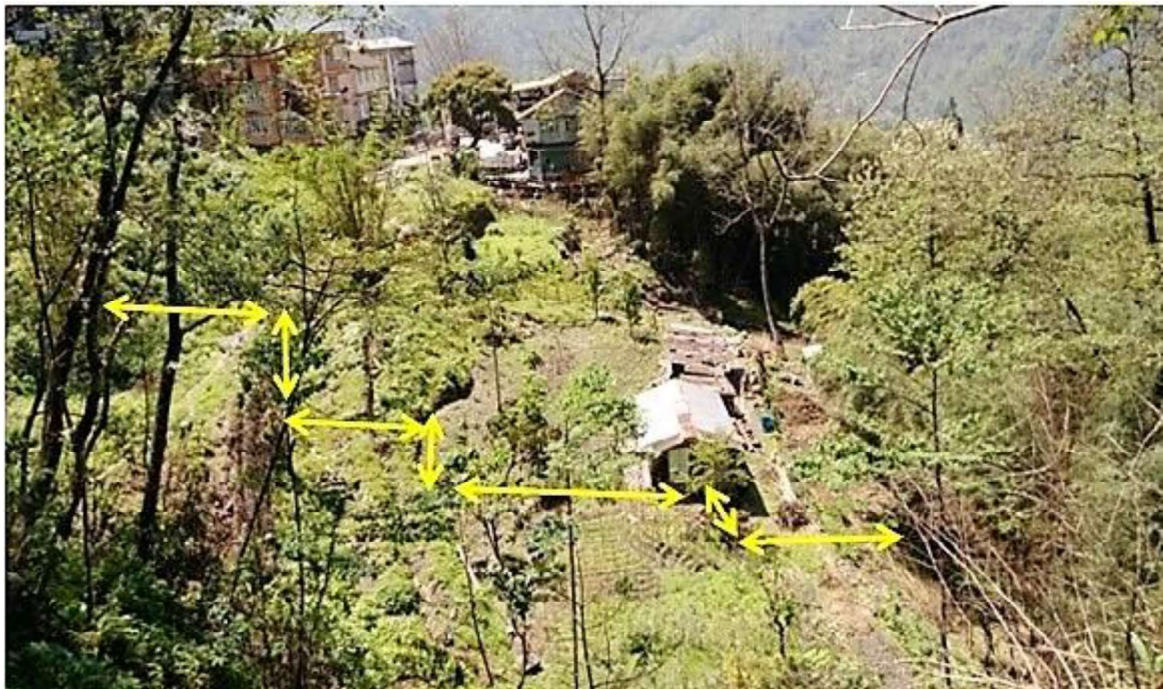
Fig 11: Showing steps due to sequential subsidence in the slide mass below SNT complex

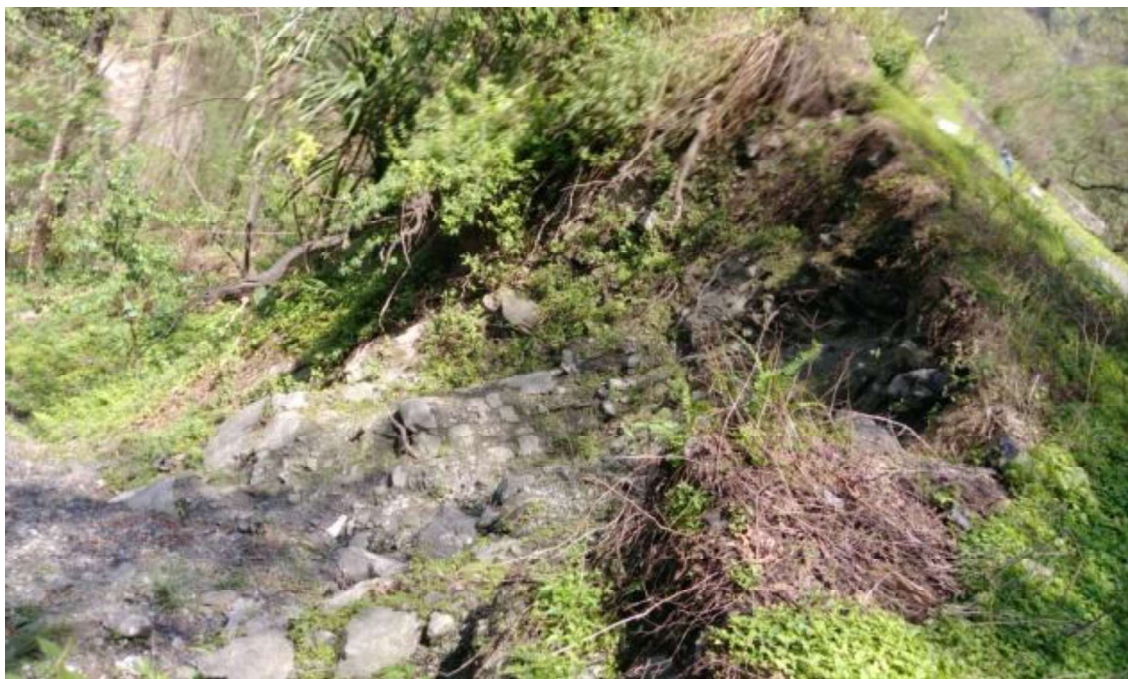
Fig 13: Showing exposed bed rock at right bank of raffongkhollajust upside or slide toe.

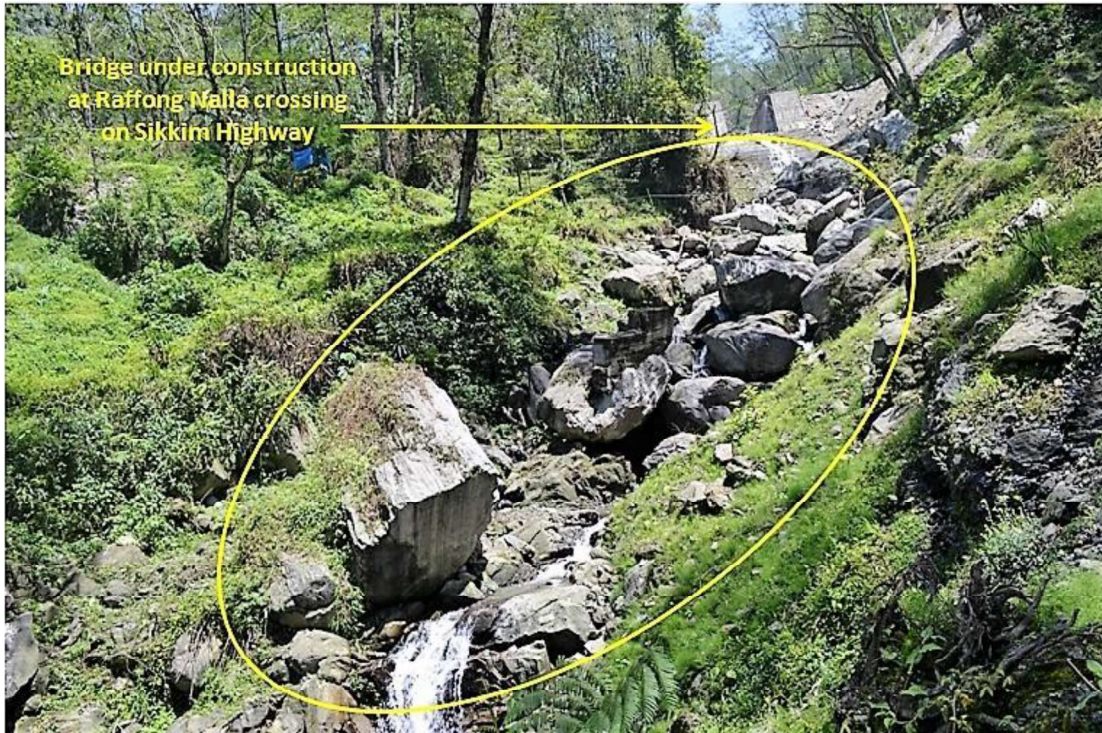
Fig 18: Upstream view of Raffong Nalla showing accumulation of huge boulder along Nalla below Sikkim highway.

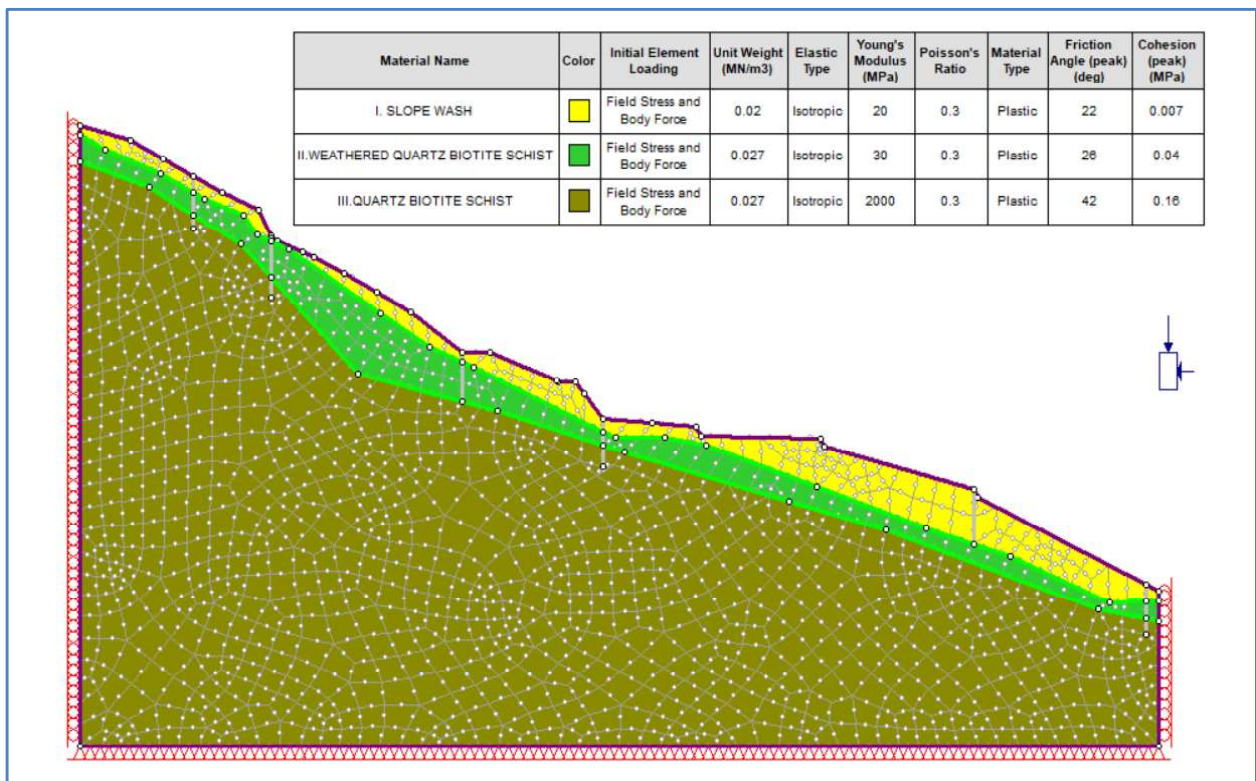
Figure 24: Discretised Model of Mangan Slide

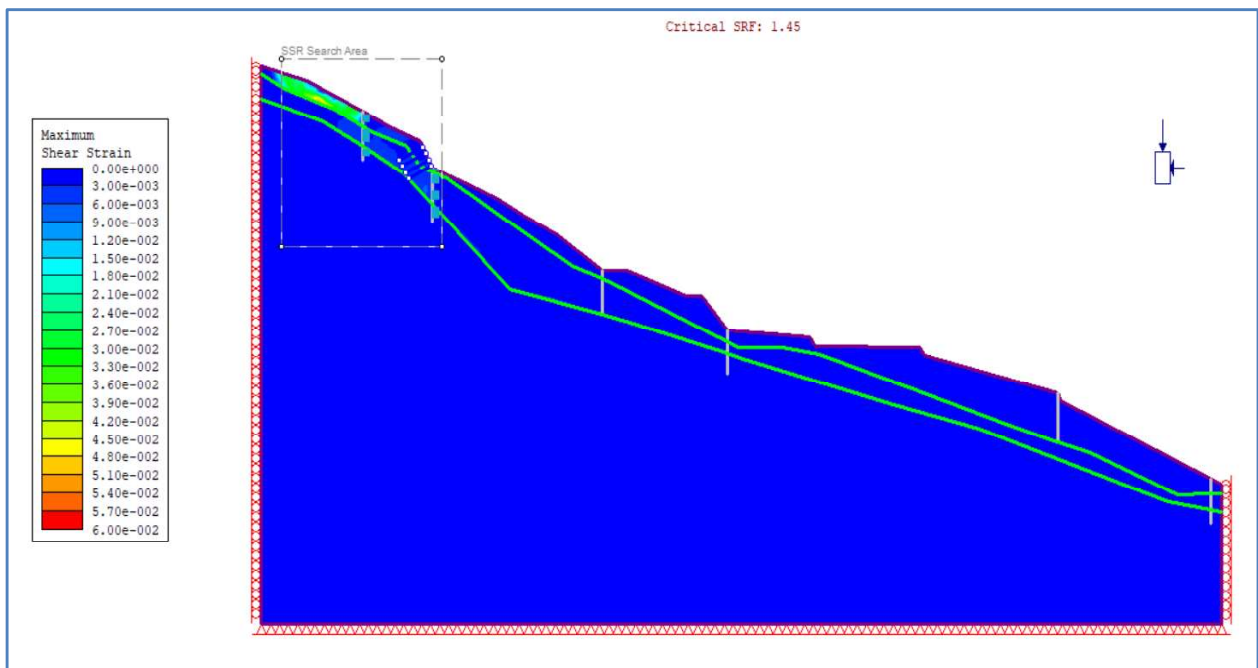
Figure 26: FOS of Safety of Mangan Slide Supported at First Level (FOS=1.45)

Support System: Support System used is 25 mm Dia, 6m long Self-Drilling Anchor along with vertical RCC pile of 0.4 m Dia at spacing at 0.5 m c/c.

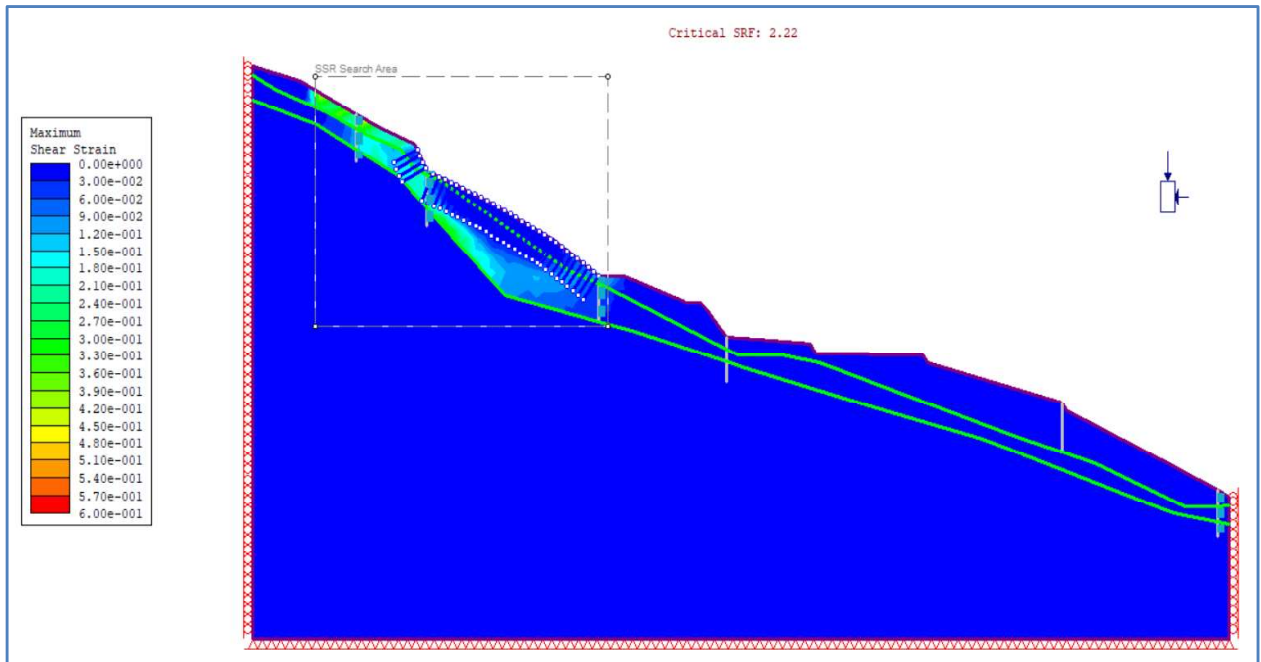
Figure 27: FOS of Safety of Mangan Slide Supported at Second Level (FOS=2.22)

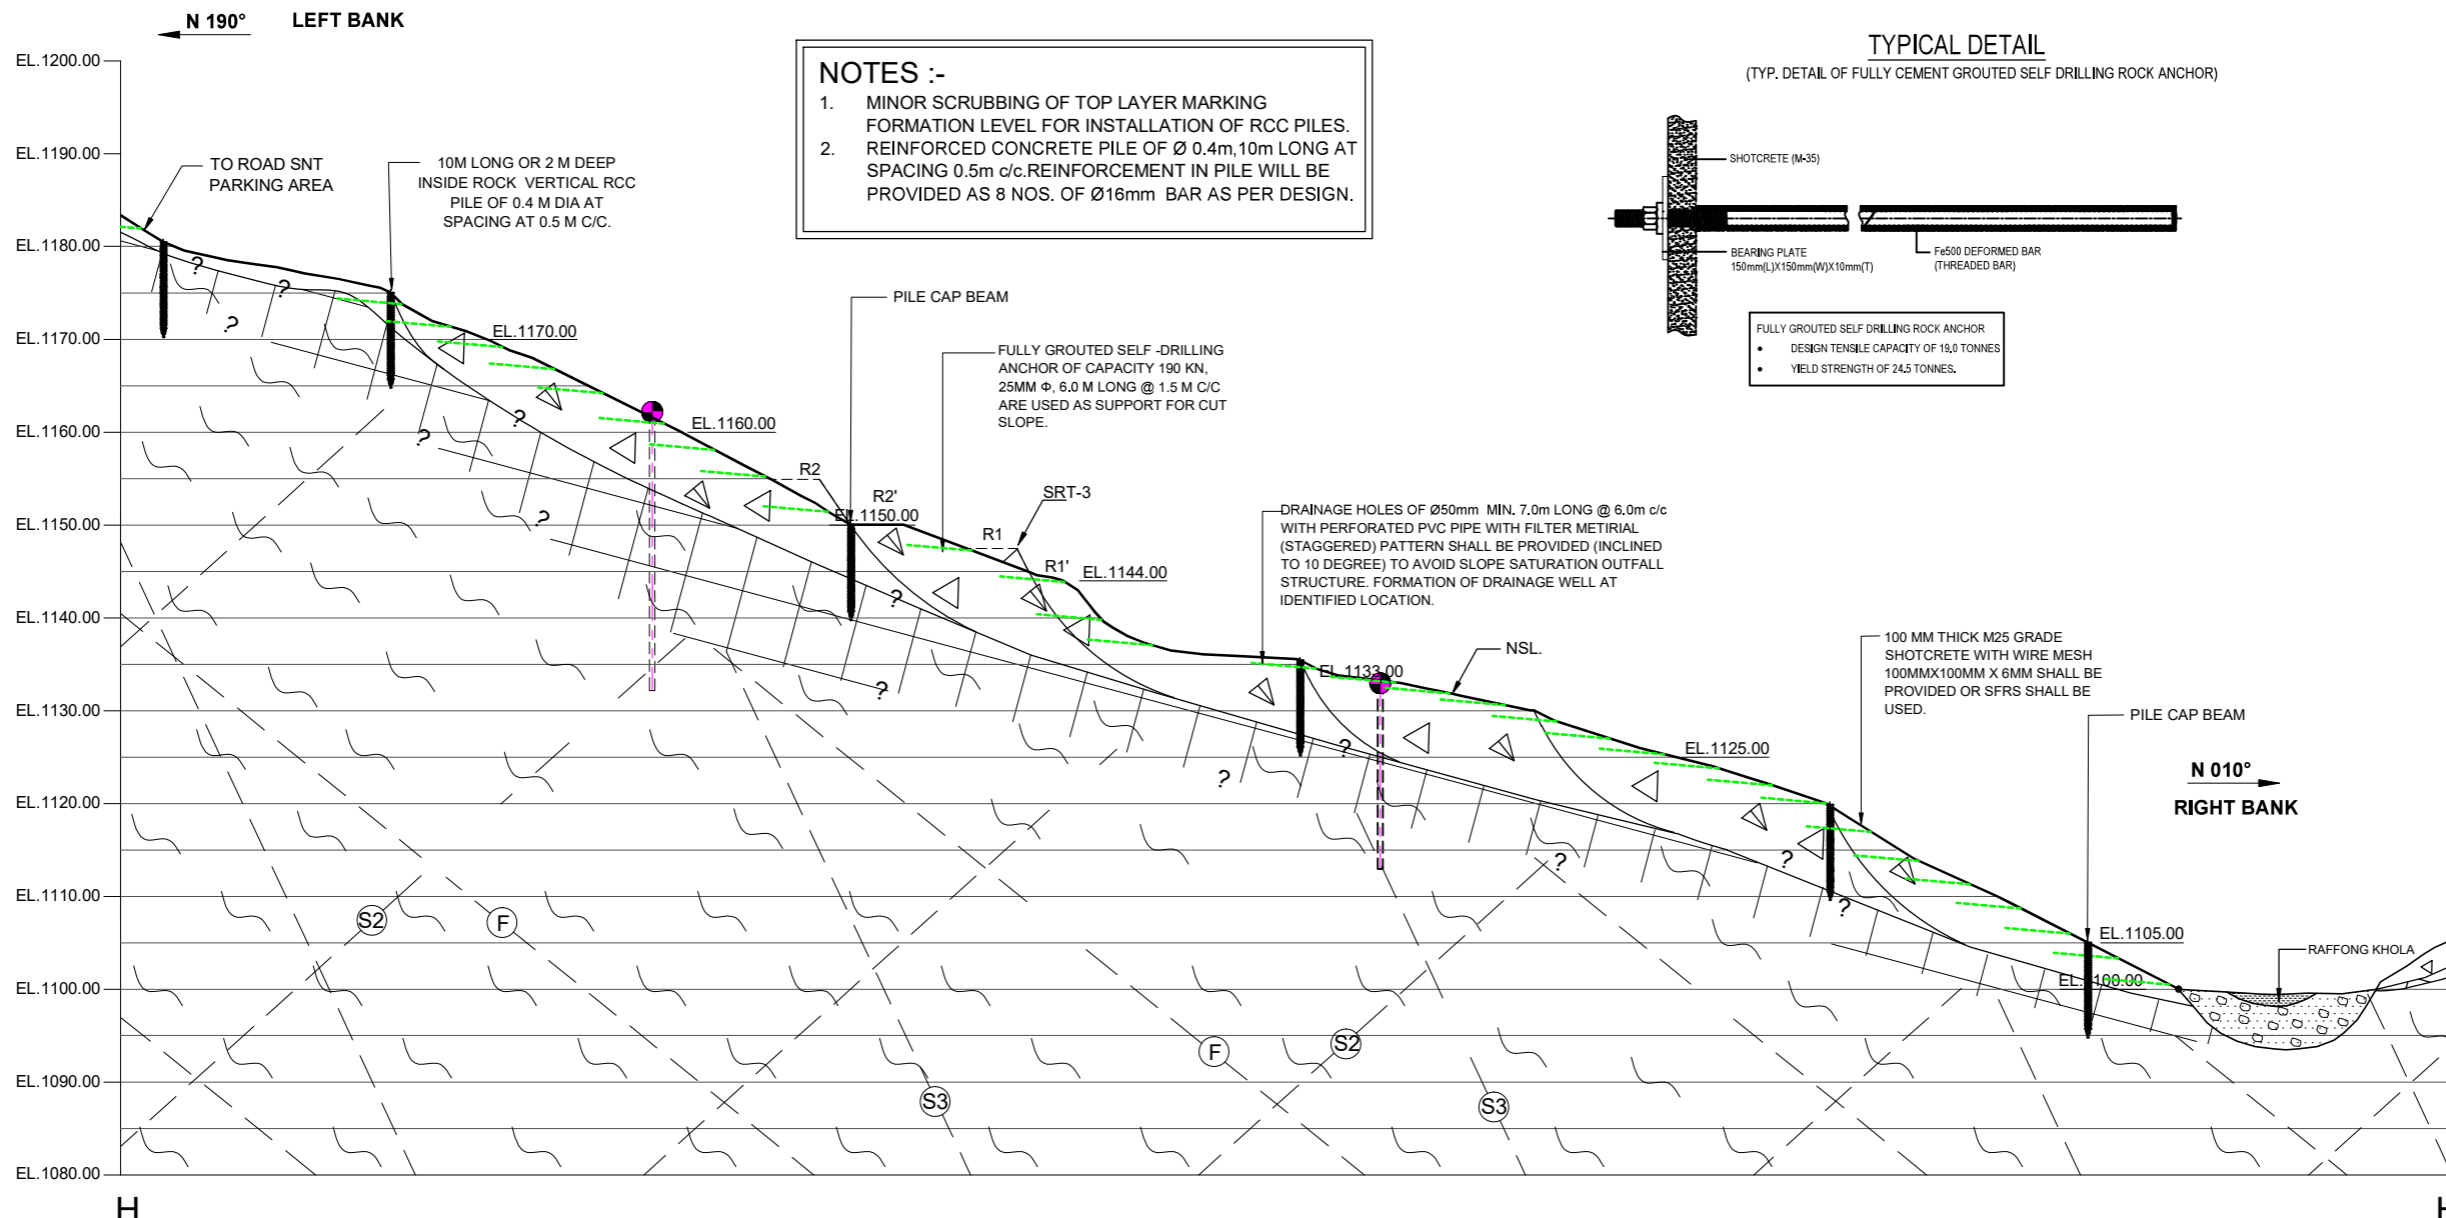
TYPICAL DETAIL
(TYP. DETAIL OF FULLY CEMENT GROUTED SELF DRILLING ROCK ANCHOR)

| Sl. No | Recommendation / Suggestion of member from GSI of TEC Experts in the Last Meeting & Clarification Sought | Clarification by the State | Reference Page no. of DPR |
|---|---|---|--|
| 2. | Self-drilling fully cement-grouted anchors with end-anchorage bulbs in zigzag (staggered) pattern with varying lengths and with increased anchor angle to penetrate beyond the interface of debris-bed rock to be applied on the slope face in between rows of the micro-piles with increased angle to be mentioned in the DPR, so that the self-driven anchors can be placed down to a greater depth. | Accepted and modified. | Incorporated in the design drawings no. Mangan/Sikkim/SSDMA-114. |
